**NORTH BEACH  
STORMWATER STUDY  
DRAFT**

**DEVELOPMENTSERVICES  
DEPARTMENT CHRISTI AND THE  
NORTH BEACH TASK FORCE**

## North Beach Streets, Water, Wastewater Study

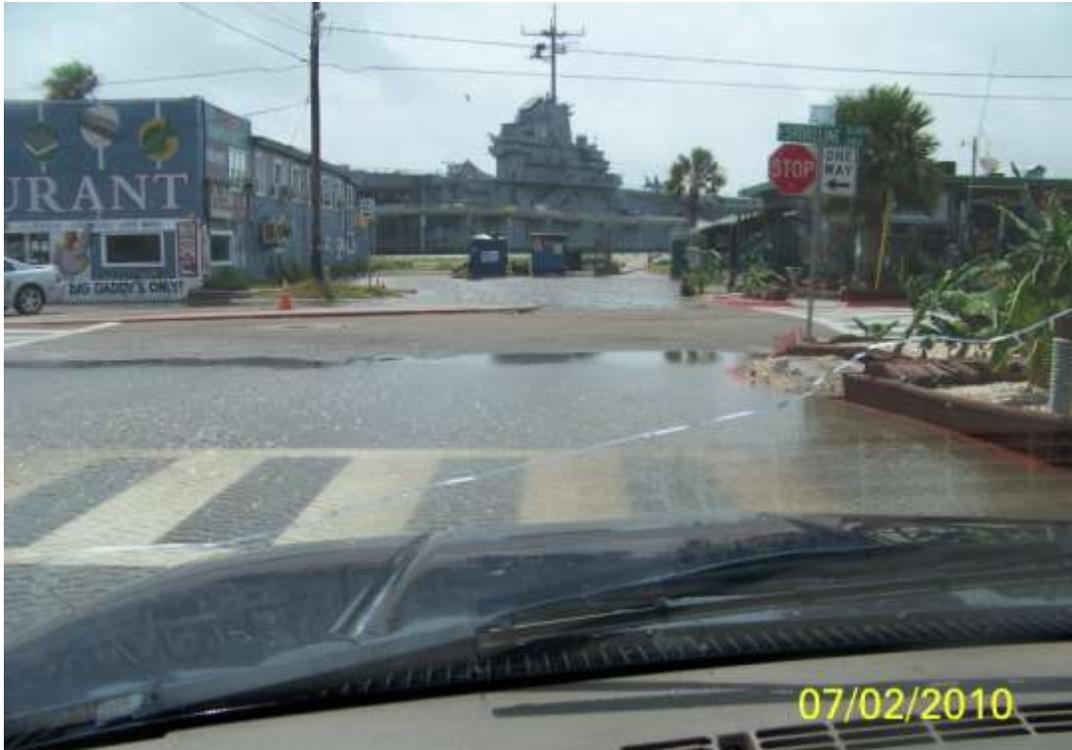
Figure 2: North Shoreline Blvd./Breakwater Ave. – East

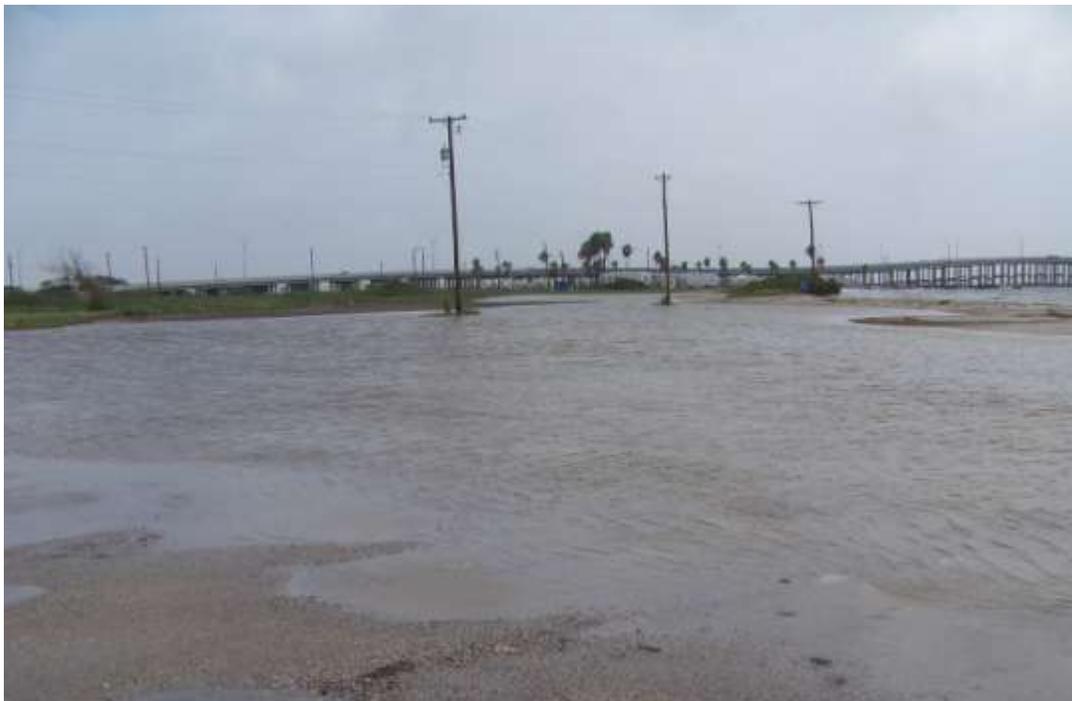
Figure 3: Dolphin Park – Looking Northwest – 7/2/2010

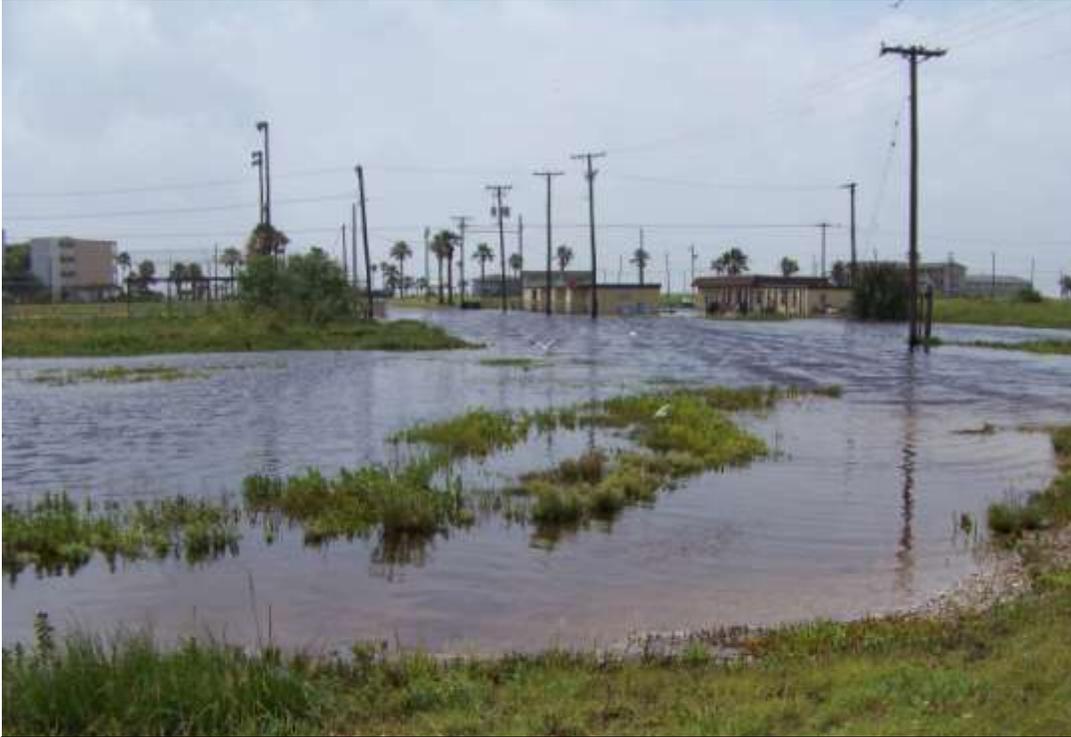
Figure 4: Tourist Avenue – Looking East from US 181 – 7/2/2010

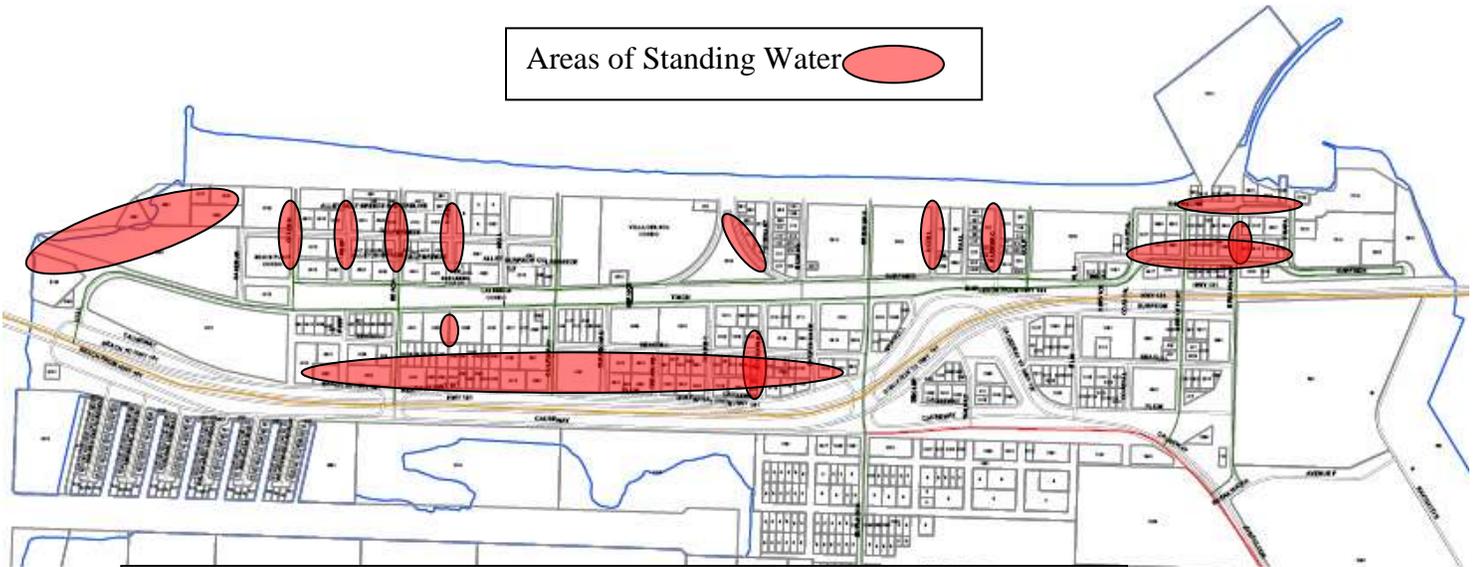
Figure 5: Storm Flooding July 2, 2010
